# Seepage Remediation

## Case Studies of Grower Practices

Case studies of projects by cotton growers  
to remedy seepage losses from on-farm storages

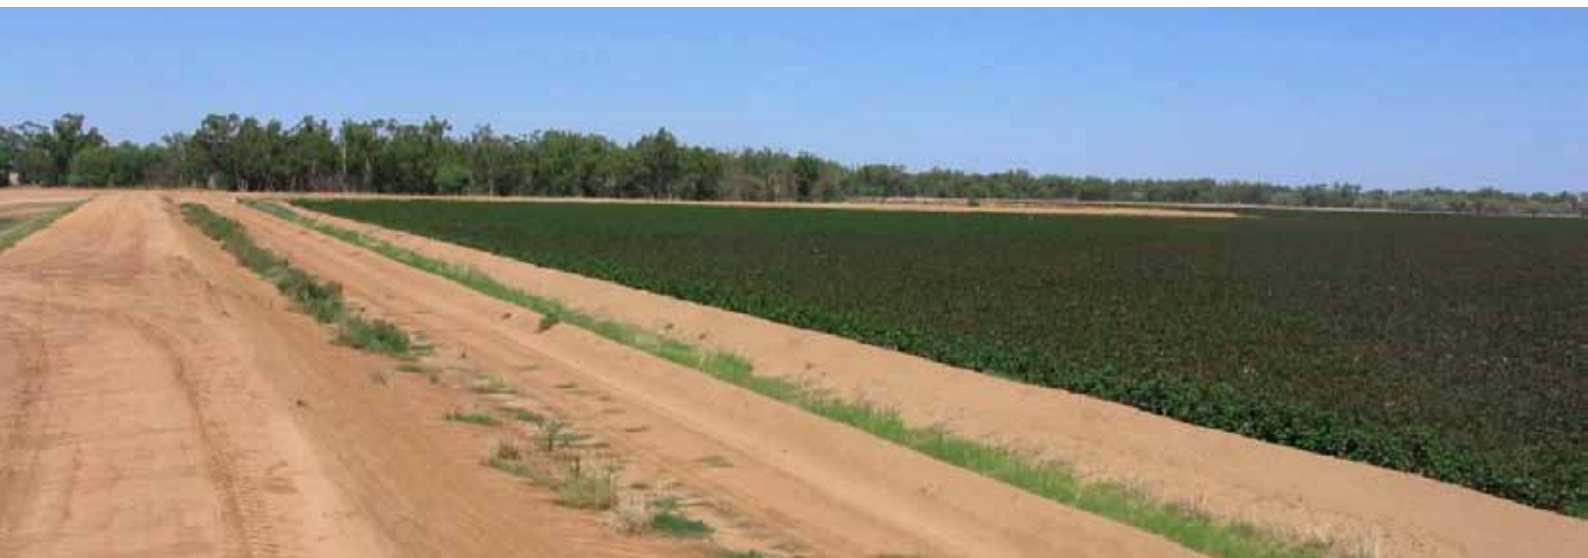
After the next season's cotton crop was planted, prolific growth of the cotton plants was observed in a specific area of the field adjacent to the water storage. The soil was boggy and wet and therefore it was assumed that water was somehow leaking from the newly filled water storage.

*Water leaks into the green area at the top of the photo, but not into the redder crop at the bottom of the photo*

The problem was managed for a few years by emptying the water storage in time to allow pick and other operations to be carried out. However, eventually it was decided to cut off the worst section of the water storage by moving part of the storage wall. The EM-31 survey map and test pit results were used to select the area of the storage to remove. The remediation design proved challenging as the leaky areas were running diagonally across the storage floor and around the inlet area.
